Potential Inter-Subbasin Transfer Areas from the Devils Lake Basin

April 2000

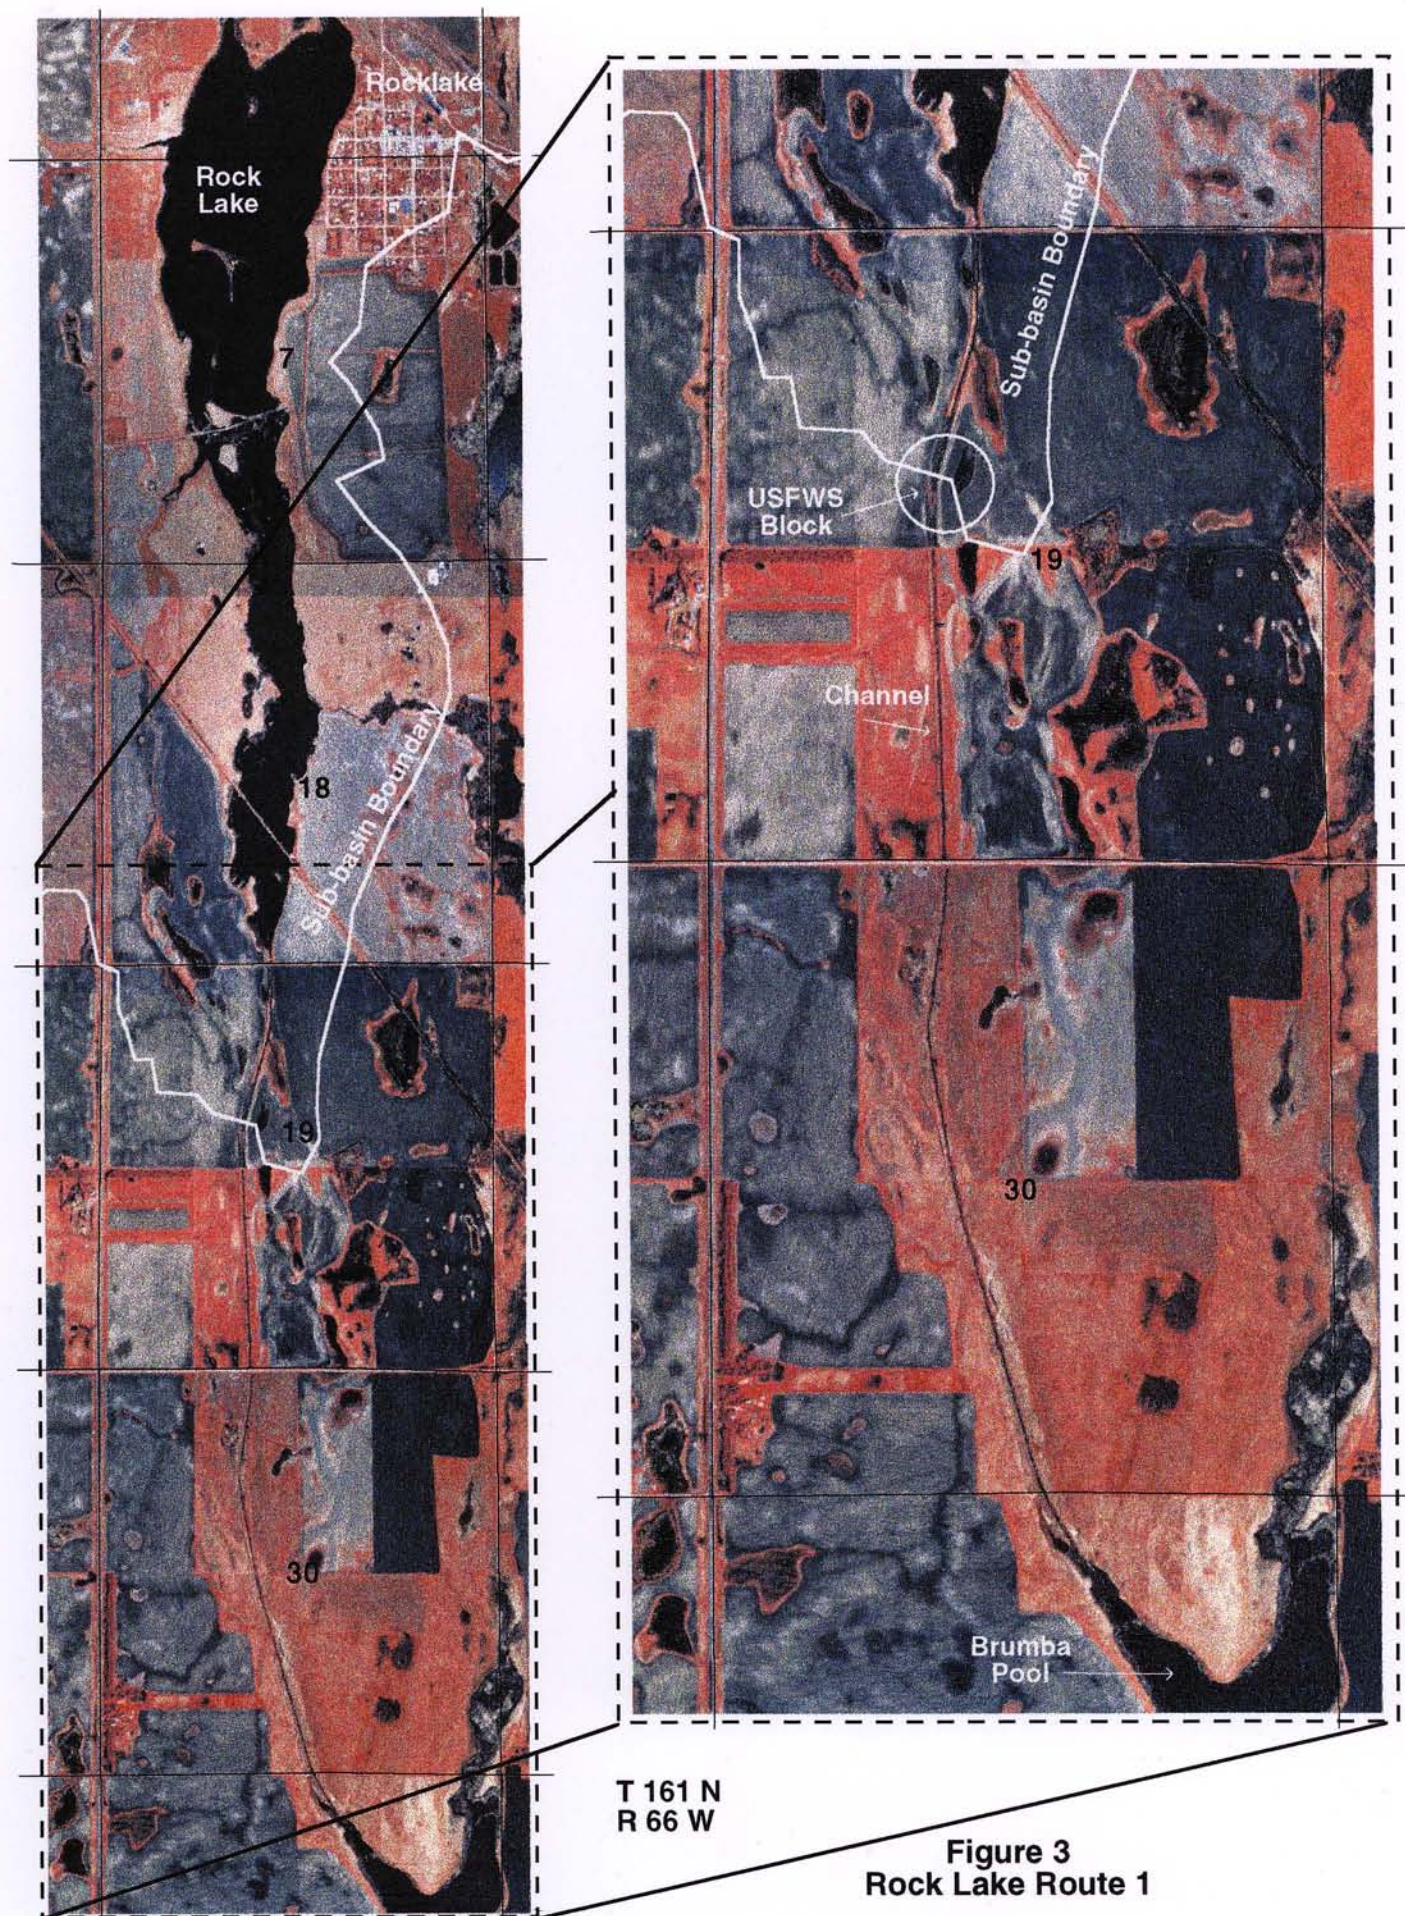
Figure 3
Rock Lake Route 1

The first area surveyed was the previously mentioned channel constructed by the Service in the 1940's to connect Rock Lake to the Mauvais Coulee (Route #1). Water leaving Rock Lake can pass into a large wetland area in Sections 7 and 18, T161-R66 through a 5-foot box culvert located at the south end of Rock Lake. The box culvert appears to drain a coulee located to the west of the wetland area in Sec. 7, T161-R66, but during above average runoff events water levels increase to a point at which the coulee, wetland area, and Rock Lake are connected. Once the water in this wetland rises, it can pass through a 48" culvert in an abandoned railroad running diagonally through Sec. 18, T161-R66. A field investigation showed this culvert to be unobstructed with the exception of some debris in the bottom of the culvert. At the south end of Section 18, 161-66, the wetland narrows into the channel constructed by the Service in the mid-1940's. Located in the channel, just north of an east-west gravel road between Sections 18 and 19 is the stoplog structure constructed by the Service to regulate flows from Rock Lake southward into Mauvais Coulee. During a site visit in May 1998, the logs were in place in the east bay, but were removed in the west bay. Through the road are two 3-foot culverts. South of the road is a channel crossing that provides access for farm equipment to move from one side of the channel to the other. Through this crossing is an 18" culvert.

Approximately 0.5 miles south of the gravel road in Sec. 19, T161-R66 is the block the Service placed in the channel to keep water from flowing south into the Mauvais Coulee. A survey of this area shows the divide to be approximately 200 feet long with a top elevation above 1533 feet msl. This high area appears to decrease the possibility that substantial amounts of water currently flow between Rock Lake and Mauvais Coulee at this location.

Color infrared photos (Figure 3) taken in early June of 1997 identifies the extent of the channel constructed by the Service. Records obtained from the Service prove that this channel provided a conduit for water to pass between Rock Lake and Devils Lake until the channel was plugged in 1955.

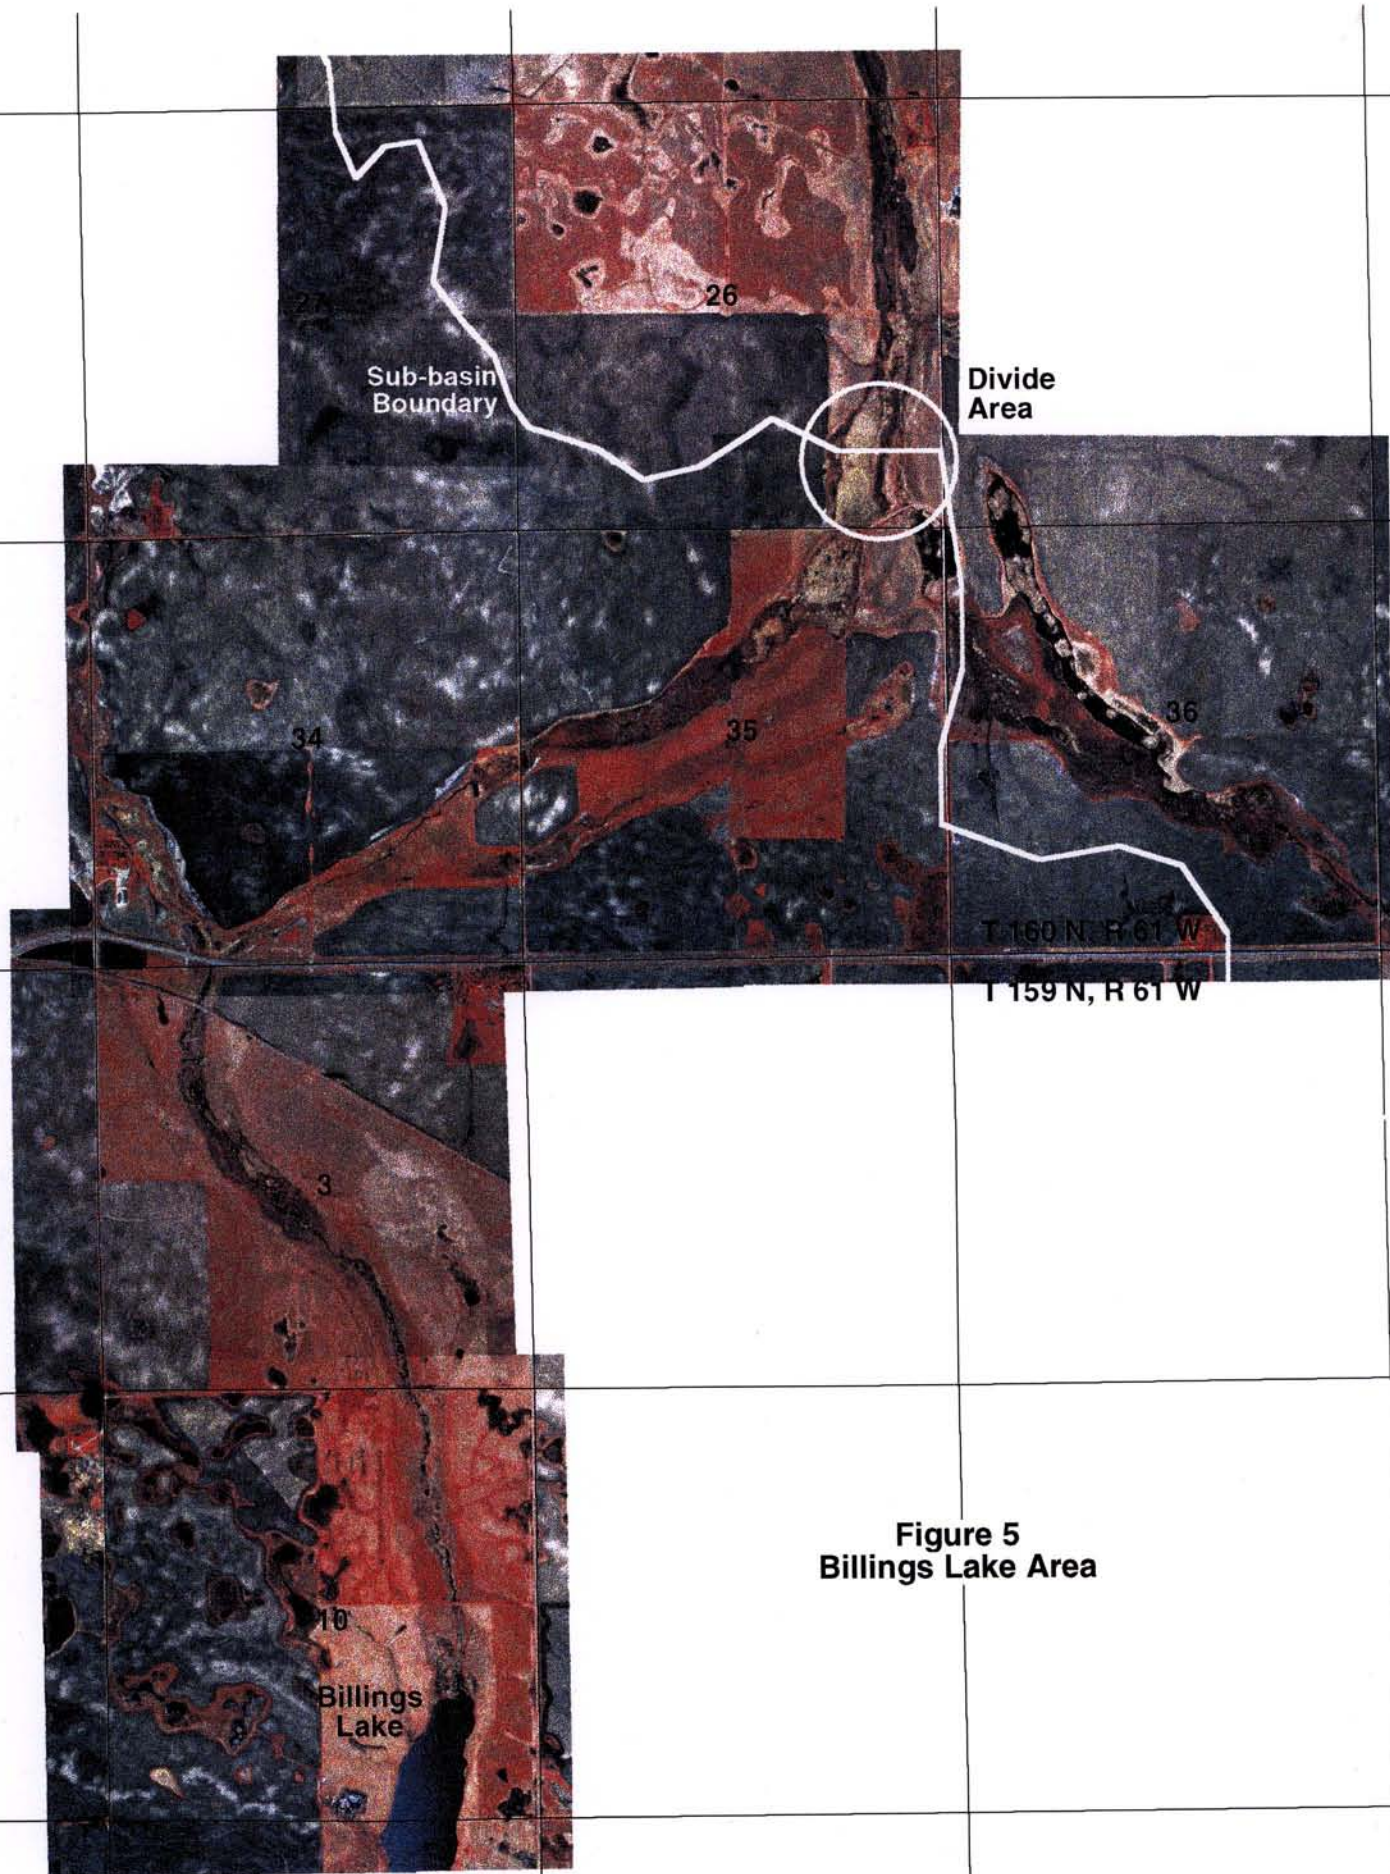
Figure 5
Billings Lake Area

This divide area was just recently brought to the attention of SWC staff and has not been surveyed. Color infrared photos (Figure 5) taken in early June of 1997 confirms that water flows across the divide, connecting the two watersheds. More information is required to better determine the extent of water transfer in this area.

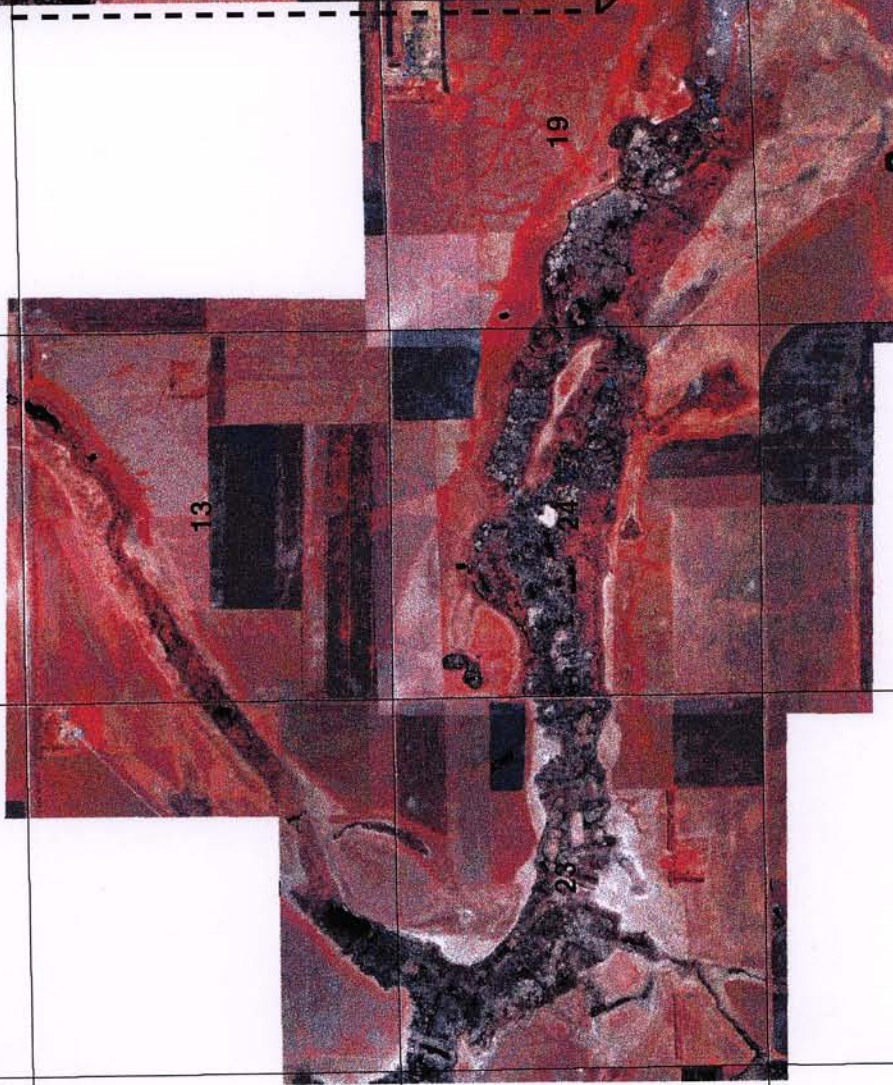
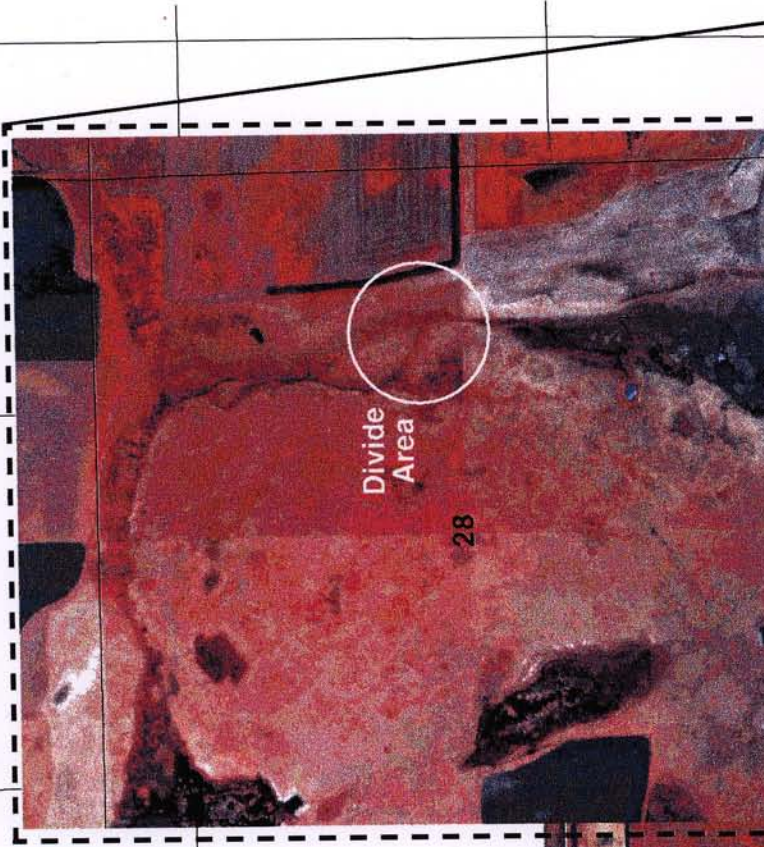
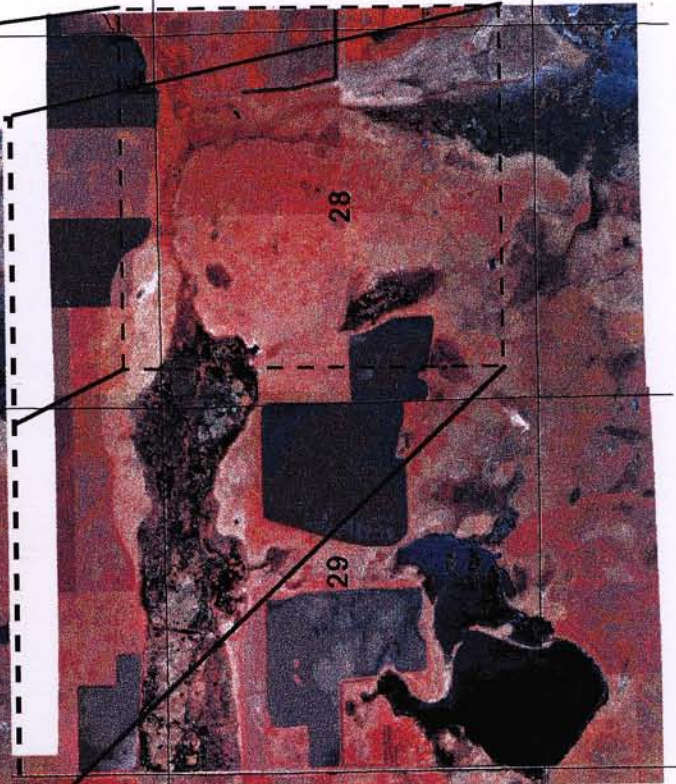
Divide
Area

Figure 6
East Devils Lake Area

The shortest route that could provide a hydrologic connection from Devils Lake to the Red River is through East Devils Lake. A channel enters East Devils Lake in the southeast 1/4 of Sec. 6, T151-R62. From the lake, this channel proceeds generally southwestward for about 18,000 feet, where it changes direction and runs east for about 24,000 feet, then it turns south and discharges into Black Slough, about 1 mile north of Hamar. Black Slough discharges into the south branch of Tolna Coulee above Snortland Dam.

This area was surveyed by the Bureau of Reclamation in the 1950's. These surveys indicate a divide is located upstream of Black Slough, in the northwest 1/4 of Sec. 28, T151-R62. The elevation of this divide appears to be about 1462 feet msl. This is approximately three feet higher than the other known outlet, that discharges from the western side of West Stump Lake into the North Branch of Tolna Coulee. However, given head losses through the lakes and connecting channels, it is likely that when Devils Lake discharged through Stump Lake, it probably discharged through the Black Slough route as well.

Color infrared photos of this area (Figure 6) indicates that, at present, this outlet conveys only local runoff into East Devils Lake north and west of the divide, and into Black Slough south and east of it. However, during the times it discharged, it would have provided a positive hydraulic connection between the Sheyenne River and Devils Lake. A field survey of this area will be conducted in order to determine the probability of overflow.
